FIGURE 3
PLAN AND LOCATION OF BORINGS AND
SECTION A-A
SANITARY LANDFILL
W.G. KRUMMRICH PLANT
SAUGET, ILLINOIS

MONSANTO COMPANY
ST. LOUIS, MISSOURI

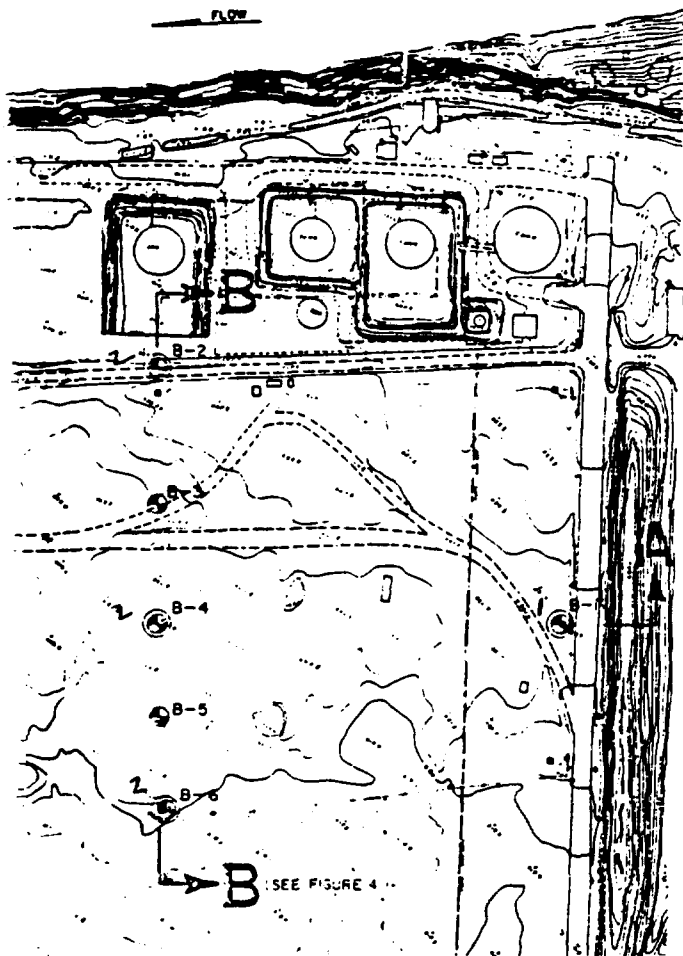
- B-3 BORING LOCATION — DRILLED UNDER D'APPOLONIA SUPERVISION
- B-4 LOCATION OF BORING IN WHICH STANDPIPE PIEZOMETER WAS INSTALLED AT COMPLETION
- 12/1/77 DATE OF OBSERVATION
- WATER LEVEL IN BORING
- PIEZOMETER SENSING ZONE

THE DEPTH AND THICKNESS OF THE SUBSURFACE STRATA INDICATED ON THE SECTIONS WERE GENERALIZED FROM AND INTERPOLATED BETWEEN THE TEST BORINGS. INFORMATION ON ACTUAL SUBSURFACE CONDITIONS EXISTS ONLY AT THE LOCATION OF THE TEST BORINGS, AND IT IS POSSIBLE THAT SUBSURFACE CONDITIONS BETWEEN THE TEST BORINGS MAY VARY FROM THOSE INDICATED.
